Technical Report No. 32-882

Mariner Mars 1964 Project Report: Spacecraft Performance and Analysis

JET PROPULSION LABORATORY
CALIFORNIA INSTITUTE OF TECHNOLOGY
PASADENA, CALIFORNIA

February 15, 1967

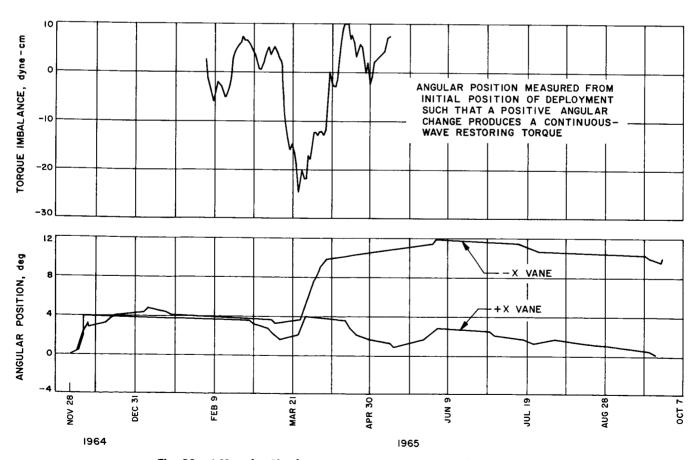
Fig. 33. +X and -X solar pressure vane movement during mission

Since the long-term disturbance torques did vary, it should be noted that the +X and -X vanes were observed moving and canceling out these disturbances in the adaptive mode of operation, Fig. 33. Figure 34 shows a representative limit axle plot for all three axes during cruise.

¹¹This represents degraded performance due to overtravel at deployment.

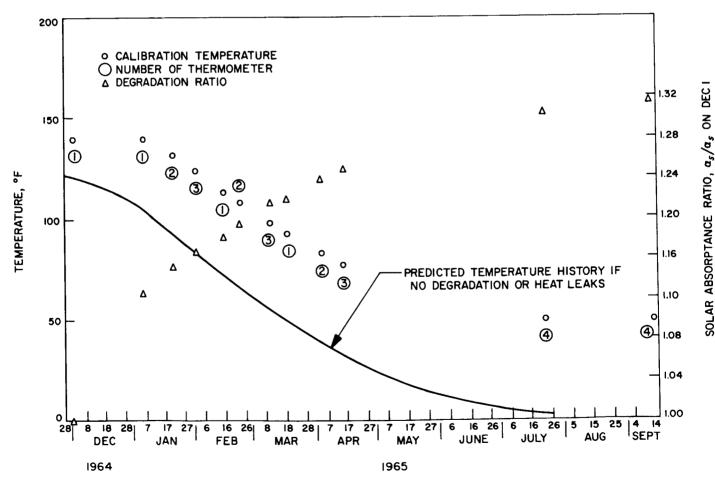
Fig. 41. Absorptivity standard performance

It was found that the wiring was reversed between the Cat-a-lac black and aluminum silicone sample sensors. The sensor idiosyncrasies made this deduction concrete by mid-January 1965. This embarrassing problem probably is due to the cable harness being fabricated to an obsolete drawing. Once this error was discovered, the data for the Cat-a-lac black paint was very consistent and predictable, showing negligible degradation. On February 13, 1965 another interesting event occurred when the black sample switched a month prematurely. This was attributed to a design oversight. The thermometers are insensitive to 100-g accelerations when the mercury meniscus is within the capillary; but, when the meniscus extends into the gas chamber, the
